THE GREAT BARN, AVEBURY (Part Two).

The following evidence is presented in support of the argument, the prime cause of the thatched roofs premature deterioration is due to poor standards of workmanship & materials used being not fit for purpose.

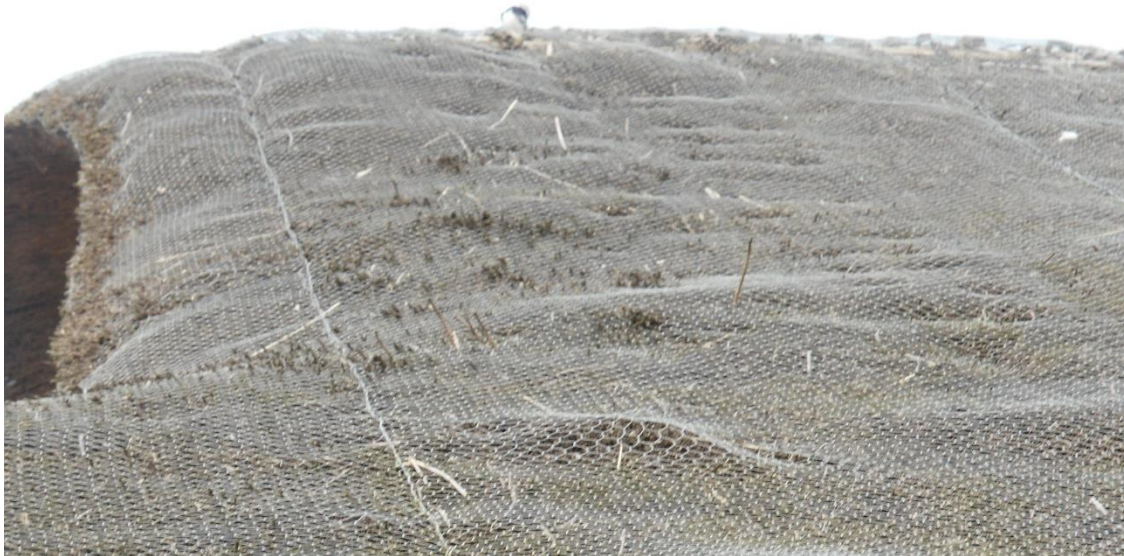
The above image shows straw from the topcoat beginning to protrude through netting high on the front elevation south west facing gable end after buffeting from high winds.

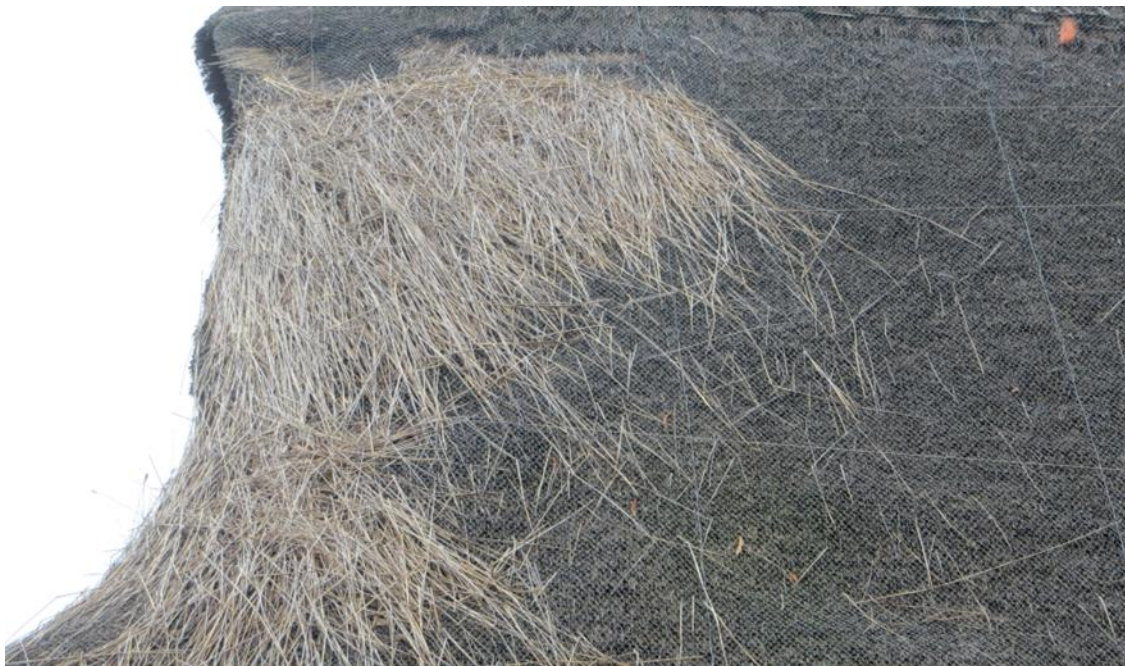
Jackdaws then draw the protruding straw onto the surface.

South West facing gable over East threshing bay shedding straw after buffeting from high winds.

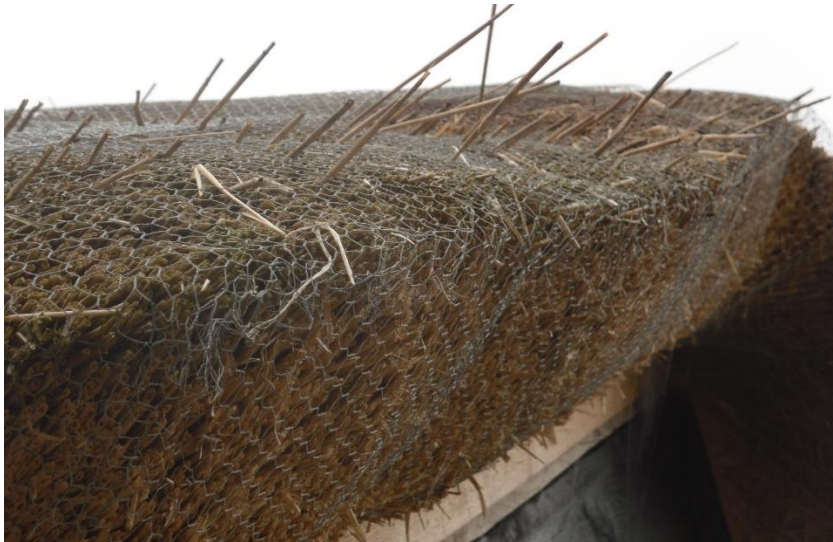
Gables are prone to damage by high winds if not thatched correctly.

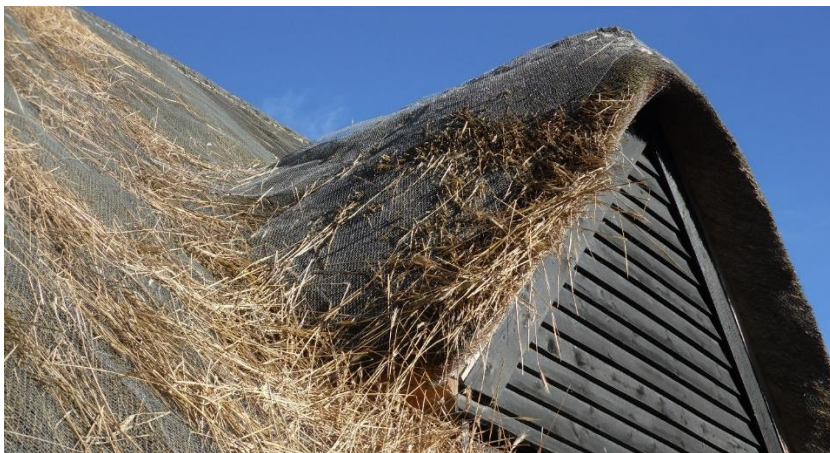
Eventually Jackdaws draw enough loose straw from the slack topcoat to cause a total collapse.

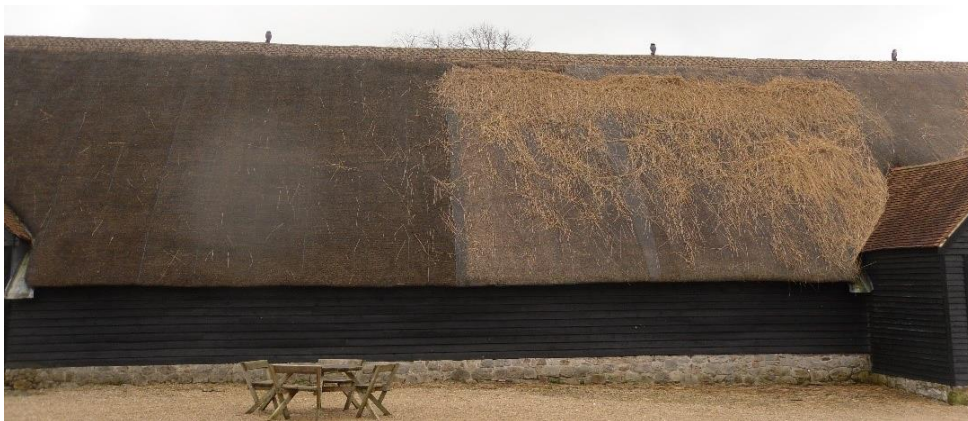
Great Barn. Rear elevation.

The following images show the results of Jackdaws drawing lengths of loose straw from the recently laid topcoat.

Note: No jackdaw activity on elevations to the left, thatched at an earlier date in a pure Wheat variety. No other thatched roofs in Avebury have been similarly affected.

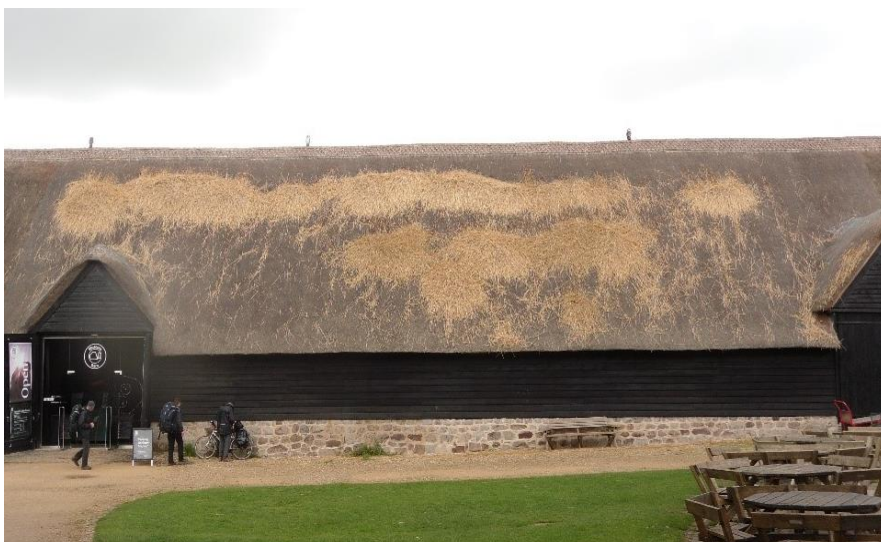
Great Barn. Front elevation.

Note: Accumulations of straw grouped together in two horizontal lines, more distinct in the following images.

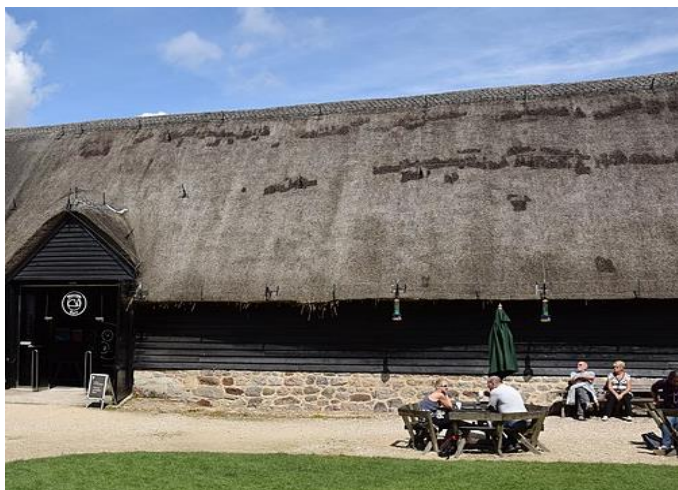
Front elevation.

Dark areas show repairs in two horizontal lines where Jackdaws had previously drawn straw from the recently applied topcoat.

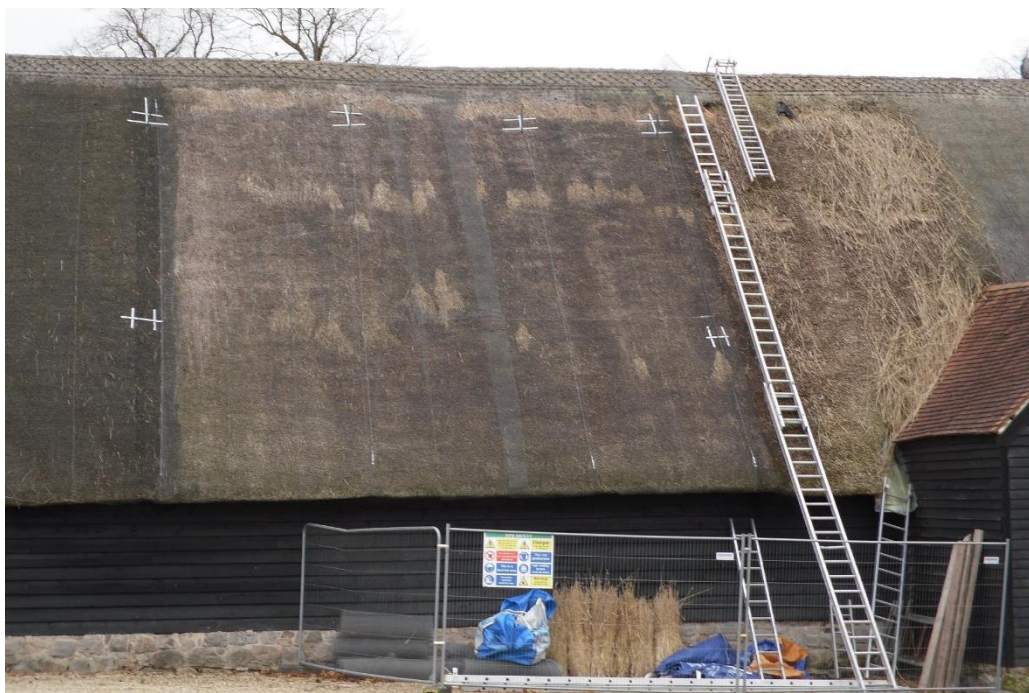
Rear Elevation.

Rear elevation repairs to the topcoat also lay in horizontal lines.

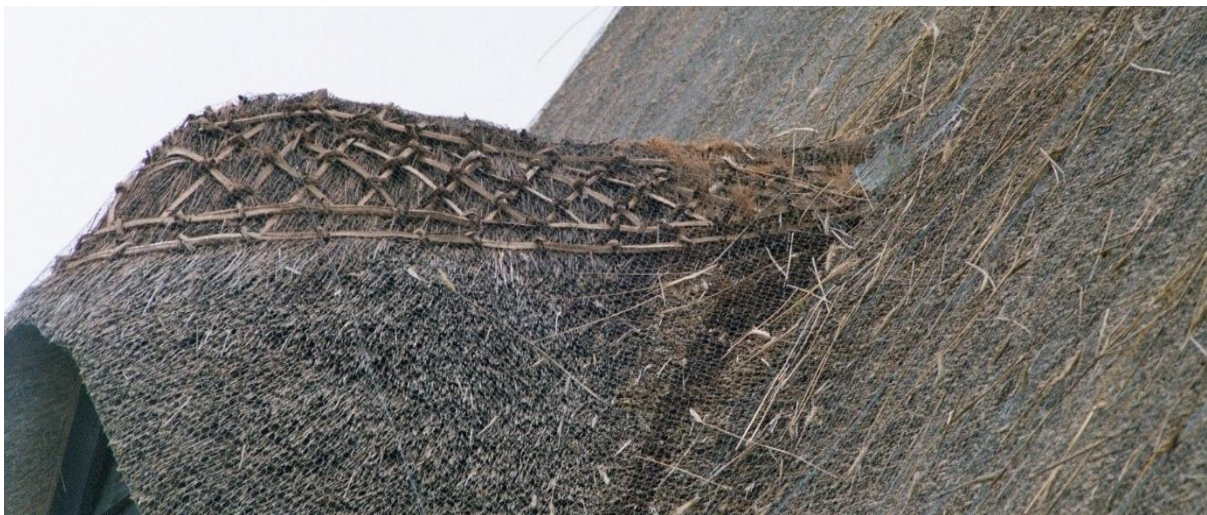
GREAT BARN MAIN ENTRANCE. Saddled ridge, 3 years after re-thatching.

At the point where the ridge meets the main elevation coat work the saddle is deficient, the ridge pitch is too flat, all surface securing spars are running downhill channelling water into the underlying topcoat resulting in severe degradation of ridge, topcoat & underlying basecoat in this vulnerable area.

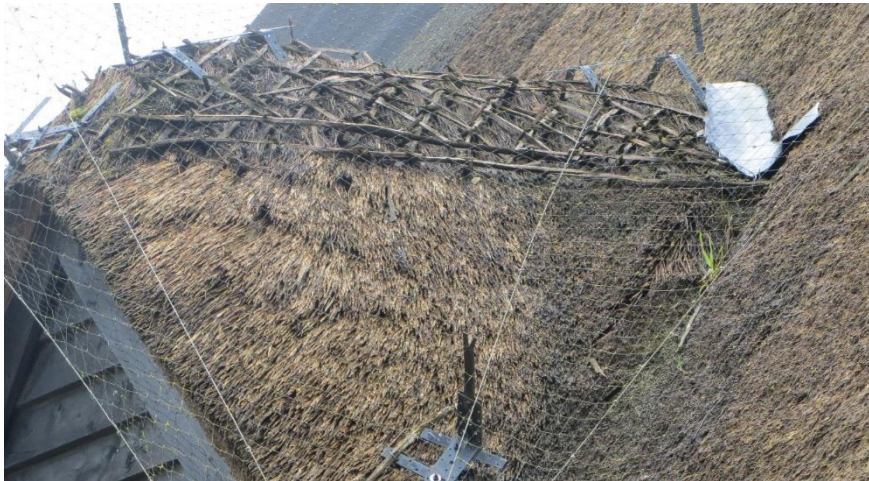
GREAT BARN MAIN ENTRANCE. Saddled ridge & right-hand valley 10 years after re-thatching.

As predicted, the right-hand valley is now collapsing due to water penetrating underlying coat-work around the saddled ridge area.

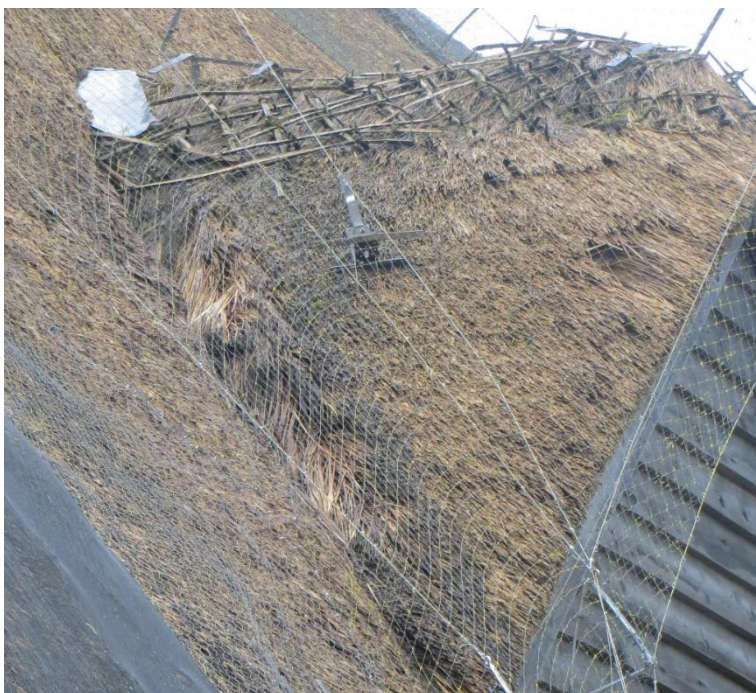
GREAT BARN MAIN ENTRANCE. February 2024 - Saddled ridge & left-hand valley 10 years after re-thatching. Both saddle & valley have collapsed & the roof is leaking.

When classified Grade 1 in 1966 the threshing bay entrances were tiled for a good reason. Thatched valleys are a high wear point, particularly when located in the lower reaches of a very long rafter length their ability to efficiently shed large volumes of rainwater is greatly diminished, which is why in days gone by valleys were often formed with lead or peg tiles.

The National Trusts conversion of the threshing bay projections from tile to thatch is a contributing factor to the roof's failure in this vulnerable area.

When next re-thatched, to avoid this potentially re-occurring problem, the projections should be tiled to conform with the original design.

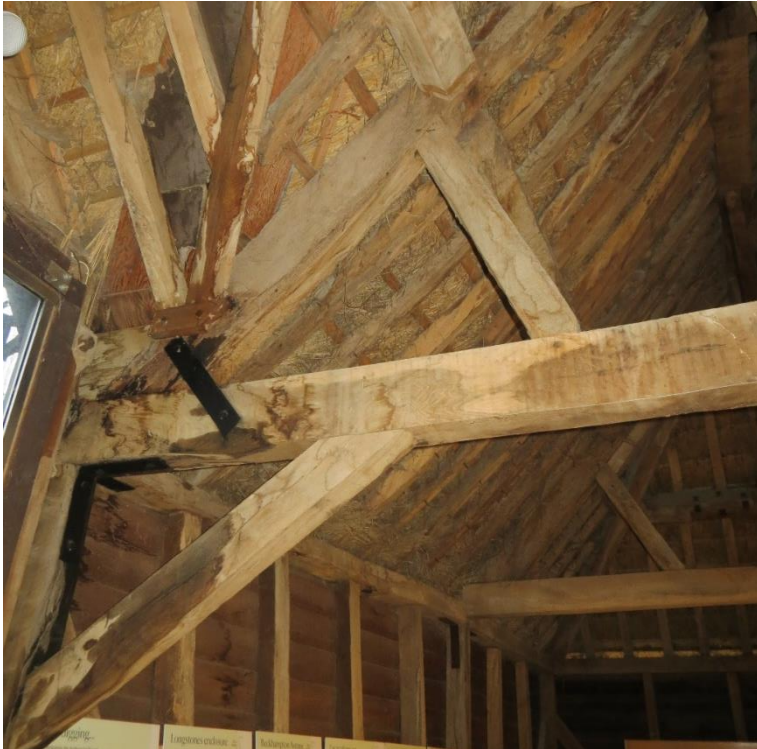
Rainwater ingress around the valley areas indicated by watermarks on roof timbers.

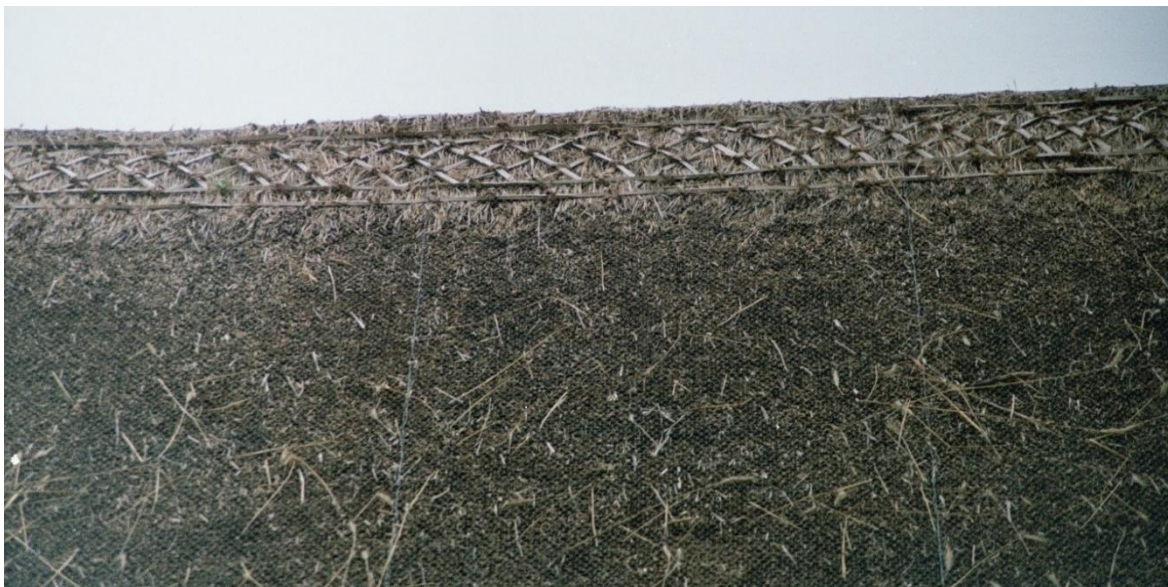
Main ridge of the Great Barn.

Image of the main ridge at 3 years of age. There are no redeeming features in this poorly constructed ridge.

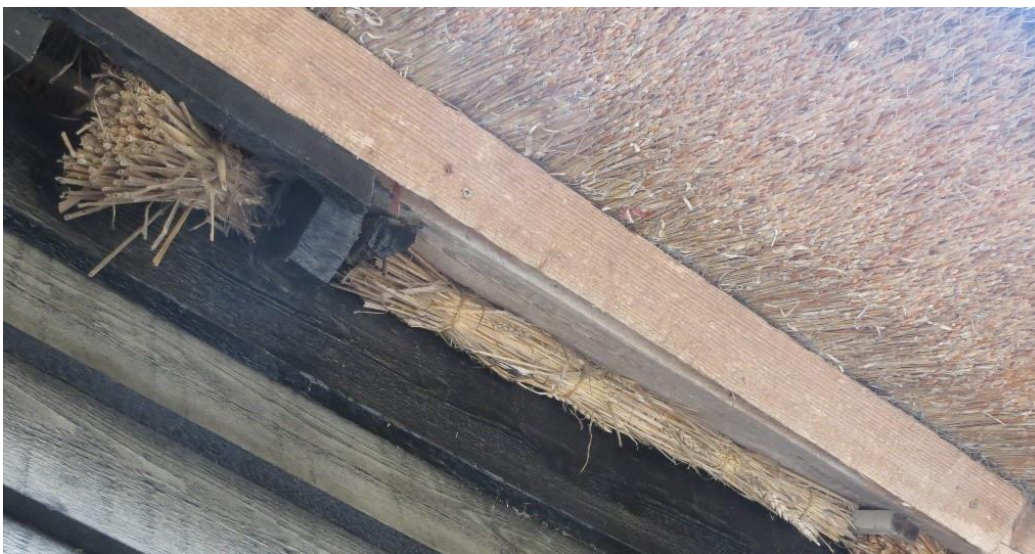
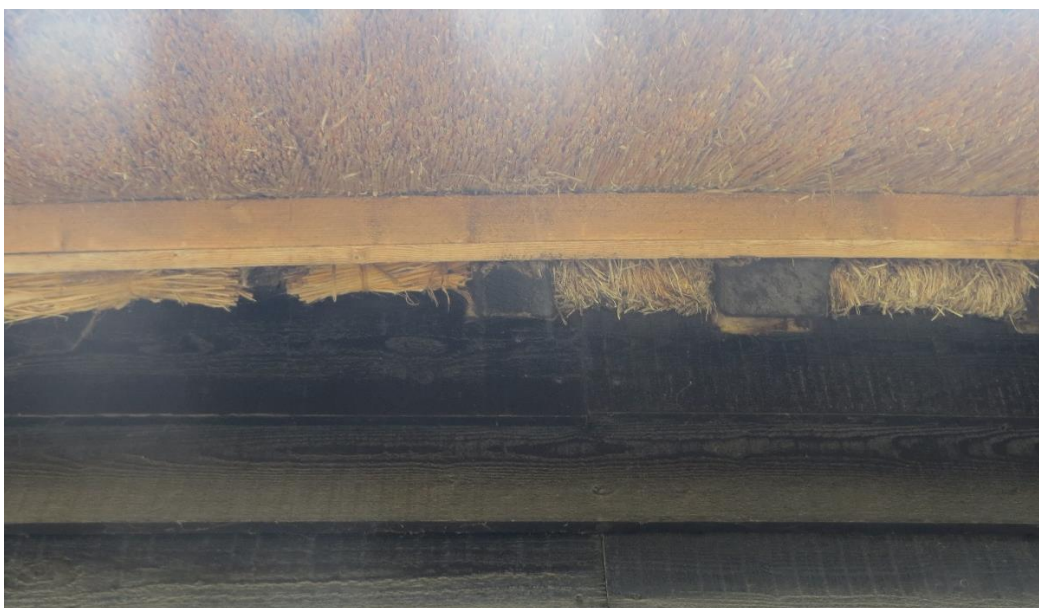
Crudely formed & poorly fitted Combed Wheat Reed rolls have replaced the original tightly knuckled Long Straw infill still visible in places.

New galvanized wire netting does not reach the wall plate allowing access for vermin around the eaves.

1960's installed knuckled long straw infill between rafters shown to the right.

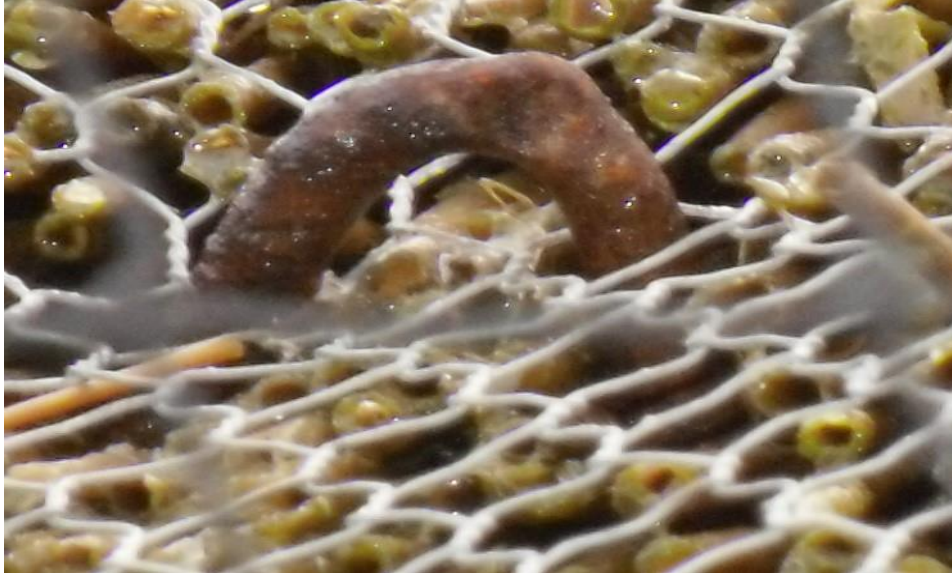
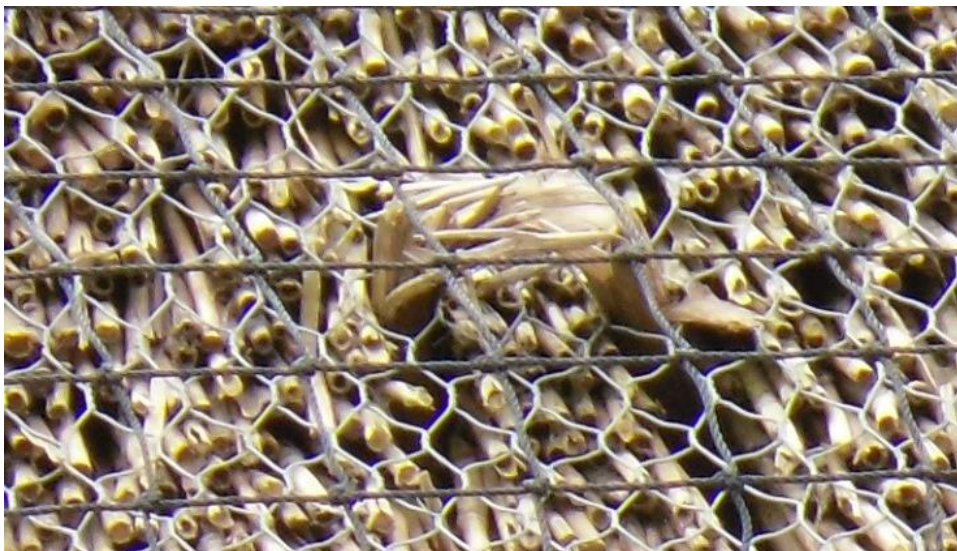
Old steel thatching crooks with shafts up to 12 inches in length pushed randomly into the topcoat with shafts pointing downhill providing a channel for rainwater to penetrate deep into the recently applied topcoat.

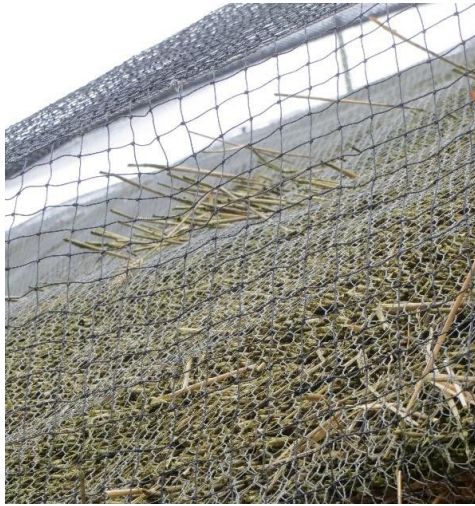
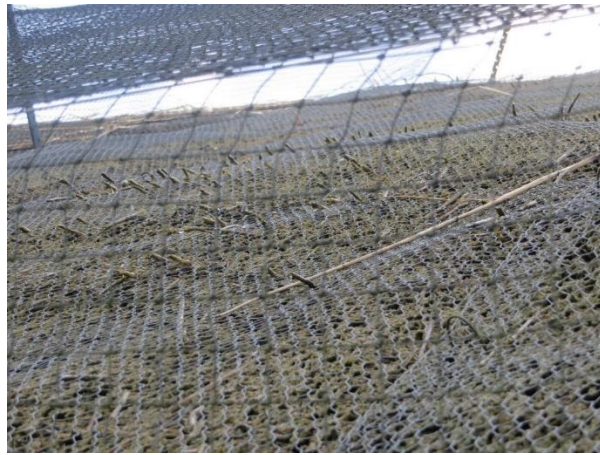
Twisted hazelwood spars placed randomly into the coat work with shafts up to 12" long pointing downhill opening the surface allowing rainwater to penetrate deep into the underlying coat work.

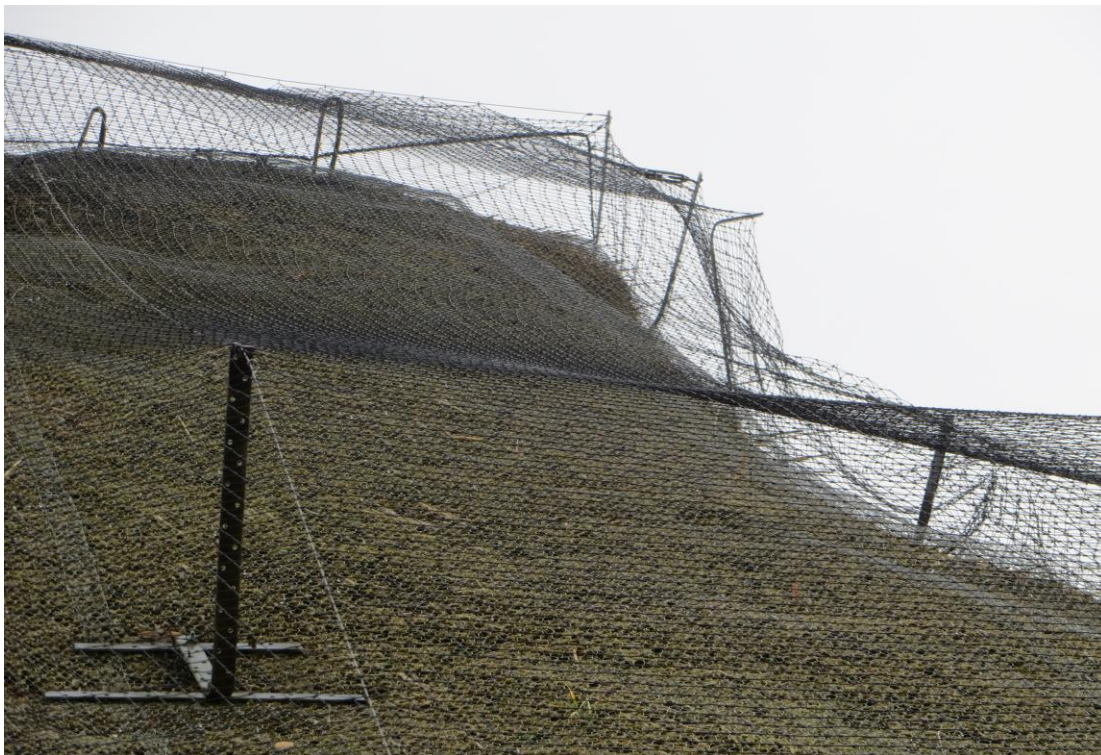
With TWO layers of galvanised wire netting applied to the surface of the thatch, together with a polypropylene netting "fruit cage" suspended two feet above the surface to deter jackdaws, the roof continues to shed straw.

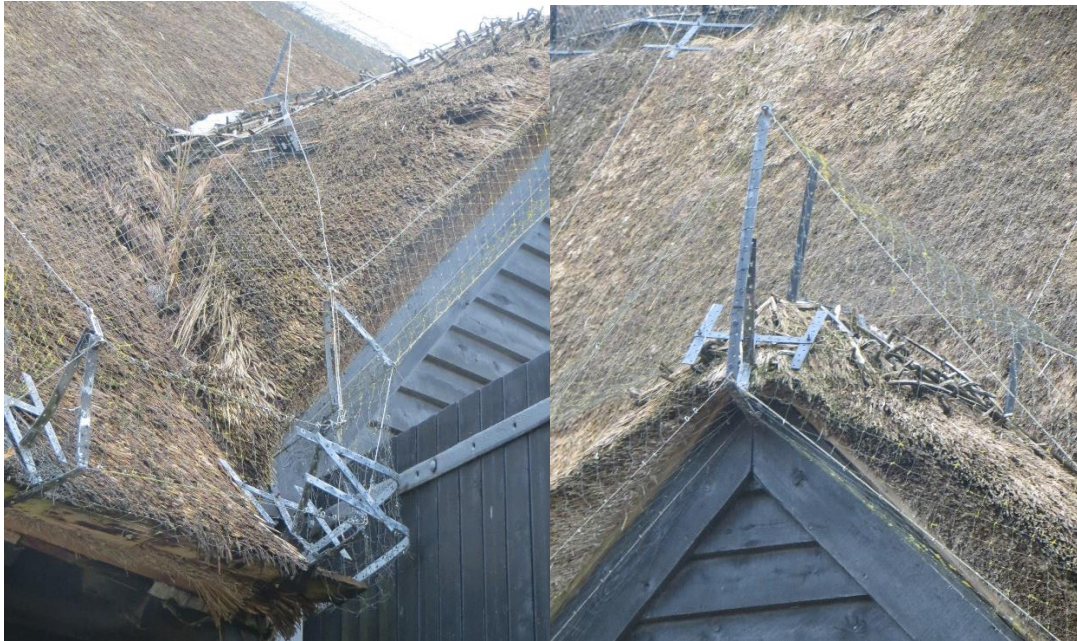
No repairs have been carried out to the Grade One Listed Barn since the valleys total collapse during the Autumn of 2023.

Images showing further deterioration of thatch March 2025.
