THE GREAT BARN, AVEBURY (Part Two).

The following evidence is presented in support of the argument, the prime cause of the thatched roofs premature deterioration is due to poor standards of workmanship & materials used being not fit for purpose.

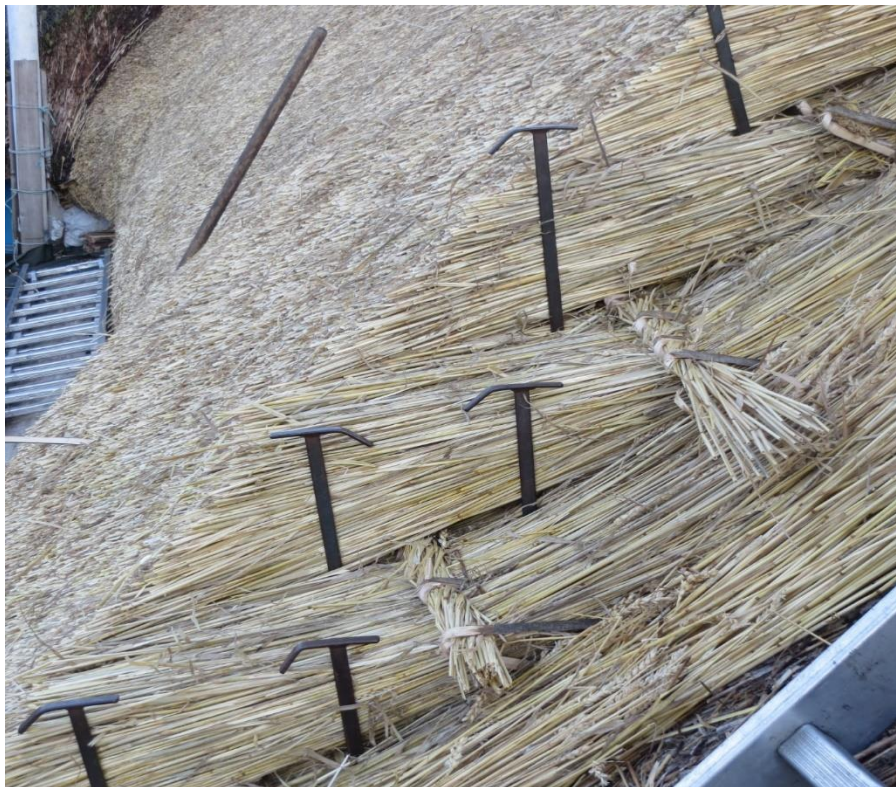
REFERENCE IMAGE. Cross section of a topcoat correctly applied.

Applying a new Combed Wheat Reed topcoat to a consolidated basecoat.

The correct size course is applied for length of material used.

Courses which are laid with too much material under the horizontal bond may result in material slippage in the lower reaches of a course due to the fixings inability to hold the material stable & tight. i.e., too big a course for the length of straw used.

This condition is exacerbated if straw is applied to a slack basecoat, which will result in loose fixings and a slack topcoat.

I suspect this to be the prime cause of the roofs failure, combined with straw of insufficient quality for use as a topcoat.

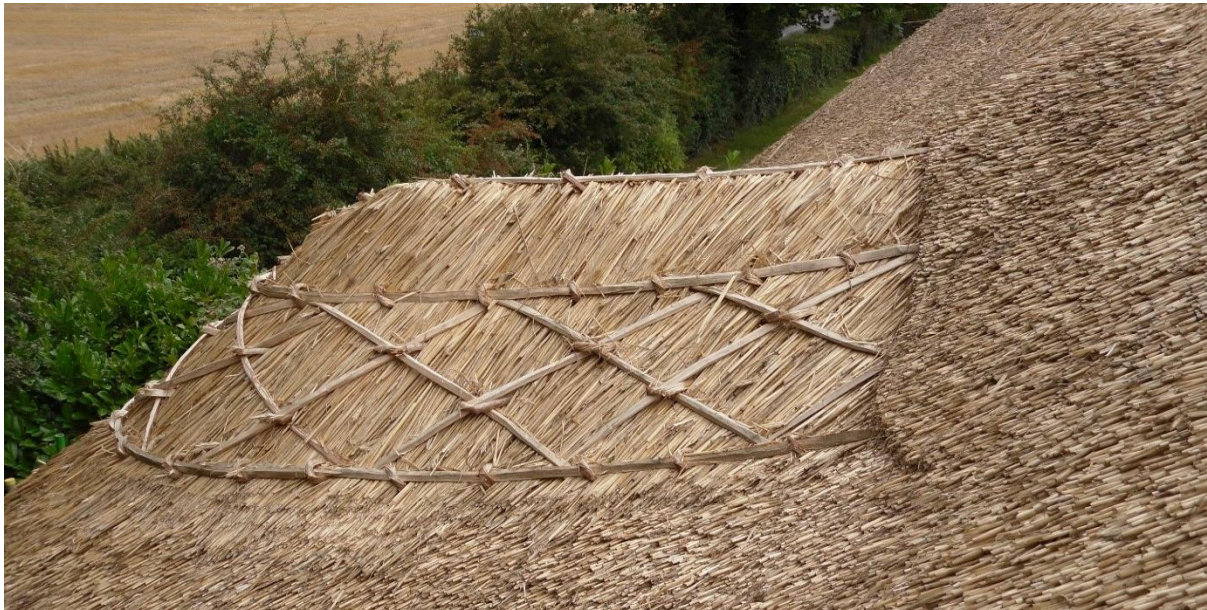
REFERENCE IMAGE. Correct construction of a “Saddled” ridge.

A steep pitch is maintained throughout the ridge length with all Hazelwood surface pattern work securing spars inserted horizontally into underlying topcoat. The direction of ridging material runs away from the junction point.
